Navajo Abandoned Uranium Mine

Site Screen Report

Mine Name: **Max Johnson No. 10**Mine ID: **128**

August 2011

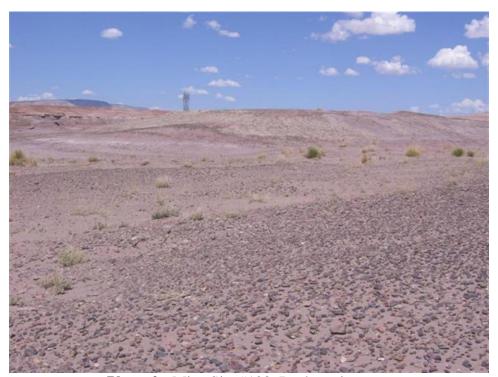
Reclamation cap in western portion of site, 250'x350'x10' oval, fine red-gray soil, no erosion control; some metal debris

Photo 2: Mine Site #128; Reclamation area
